Manhole Inspection Summary

Manhole # S33E__004MH

Inspection ☐ Is Incomplete Rating: **4) Poor**

Location Address: **120 w fayette st**

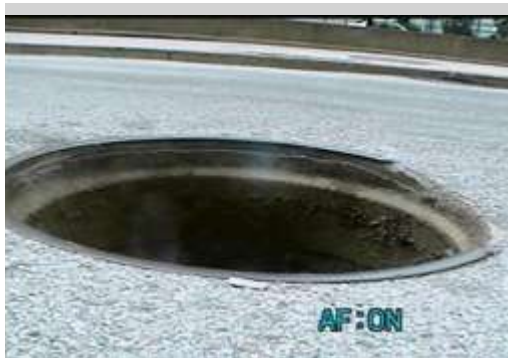
Location View

Location and missing frame

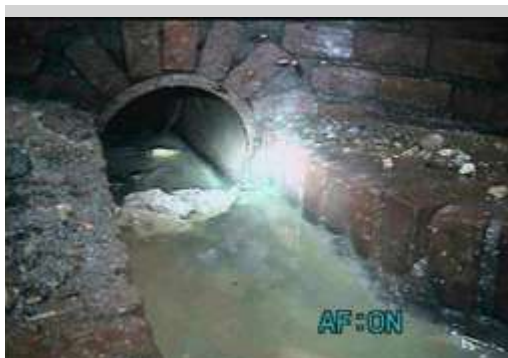
Defect 5

Condition: ☐ Sound ☐ Cracked ☐ Root Intrusion ☐ Deteriorated ☐ Leaks ☒ **Debris**

channel debris

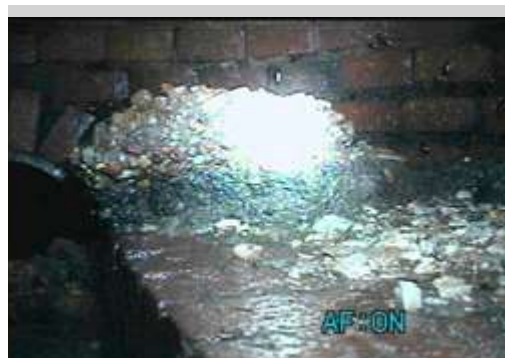
Defect

Condition: ☐ Sound ☐ Cracked ☐ Root Intrusion ☐ Deteriorated ☐ Leaks ☒ **Debris**

bench debris

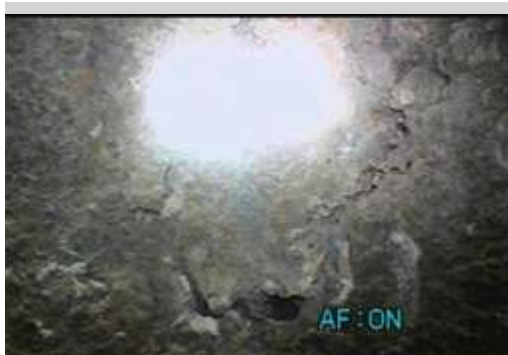
Defect 3

Condition: ☐ Sound ☒ **Cracked** ☐ Root Intrusion ☐ Loose Brick ☐ Deteriorated

crack in barrel

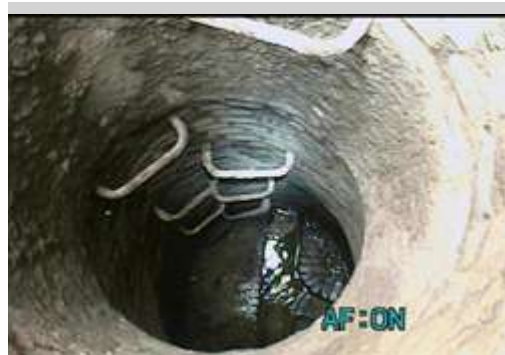
Defect 2

Count: **8** Missing: **0** ☒ **Corroded**

steps

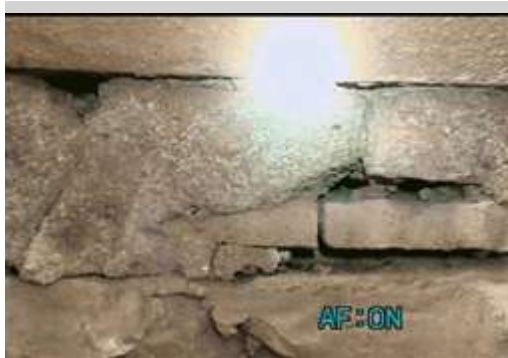
Defect 1

Condition: ☐ Sound ☒ **Cracked** ☐ Root Intrusion ☐ Loose Brick ☒ **Deteriorated**

chimney cracked, deteriorated

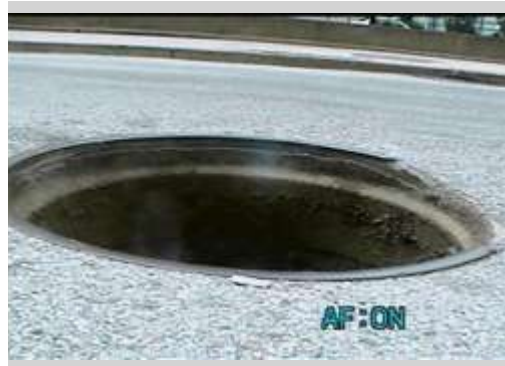
Defect

Condition: ☐ Sound ☒ **Cracked** ☐ Leaks

defective frame

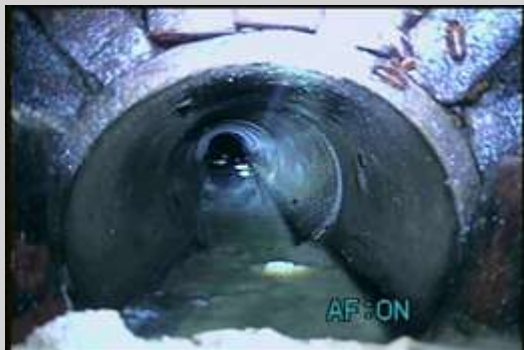
12 O'Clock Outflow

10 in. Circular Gravity Sewer
Pipe Out @ 12 O'Clock

Invert Depth: 17.25 (ft.) Flow Characteristics: **Slow**

Infiltration: **None** Pipe Seal Cond: **Unknown**

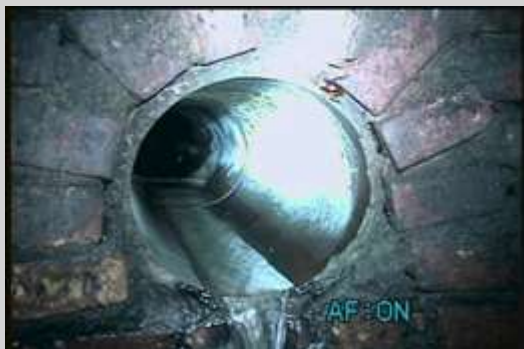
3 O'Clock Inflow

8 in. Circular Gravity Sewer
Pipe In @ 3 O'Clock

Invert Depth: 14.20 (ft.) Flow Characteristics: **Fast**

Infiltration: **None** Pipe Seal Cond: **Unknown**

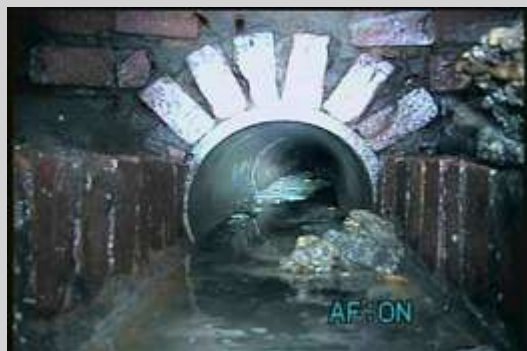
6 O'Clock Inflow

10 in. Circular Gravity Sewer
Pipe In @ 6 O'Clock

Invert Depth: **17.00** (ft.) Flow Characteristics: **Fast**

Infiltration: **None** Pipe Seal Cond: **Unknown**
